**NATIONAL TRANSPORTATION SAFETY BOARD
WASHINGTON, D.C.**

FIRE AND EXPLOSION GROUPS FACTUAL REPORT

**Appendix III
(Tests and Study)
(81 pages)**

TWA FLIGHT 800 ACCIDENT INVESTIGATION

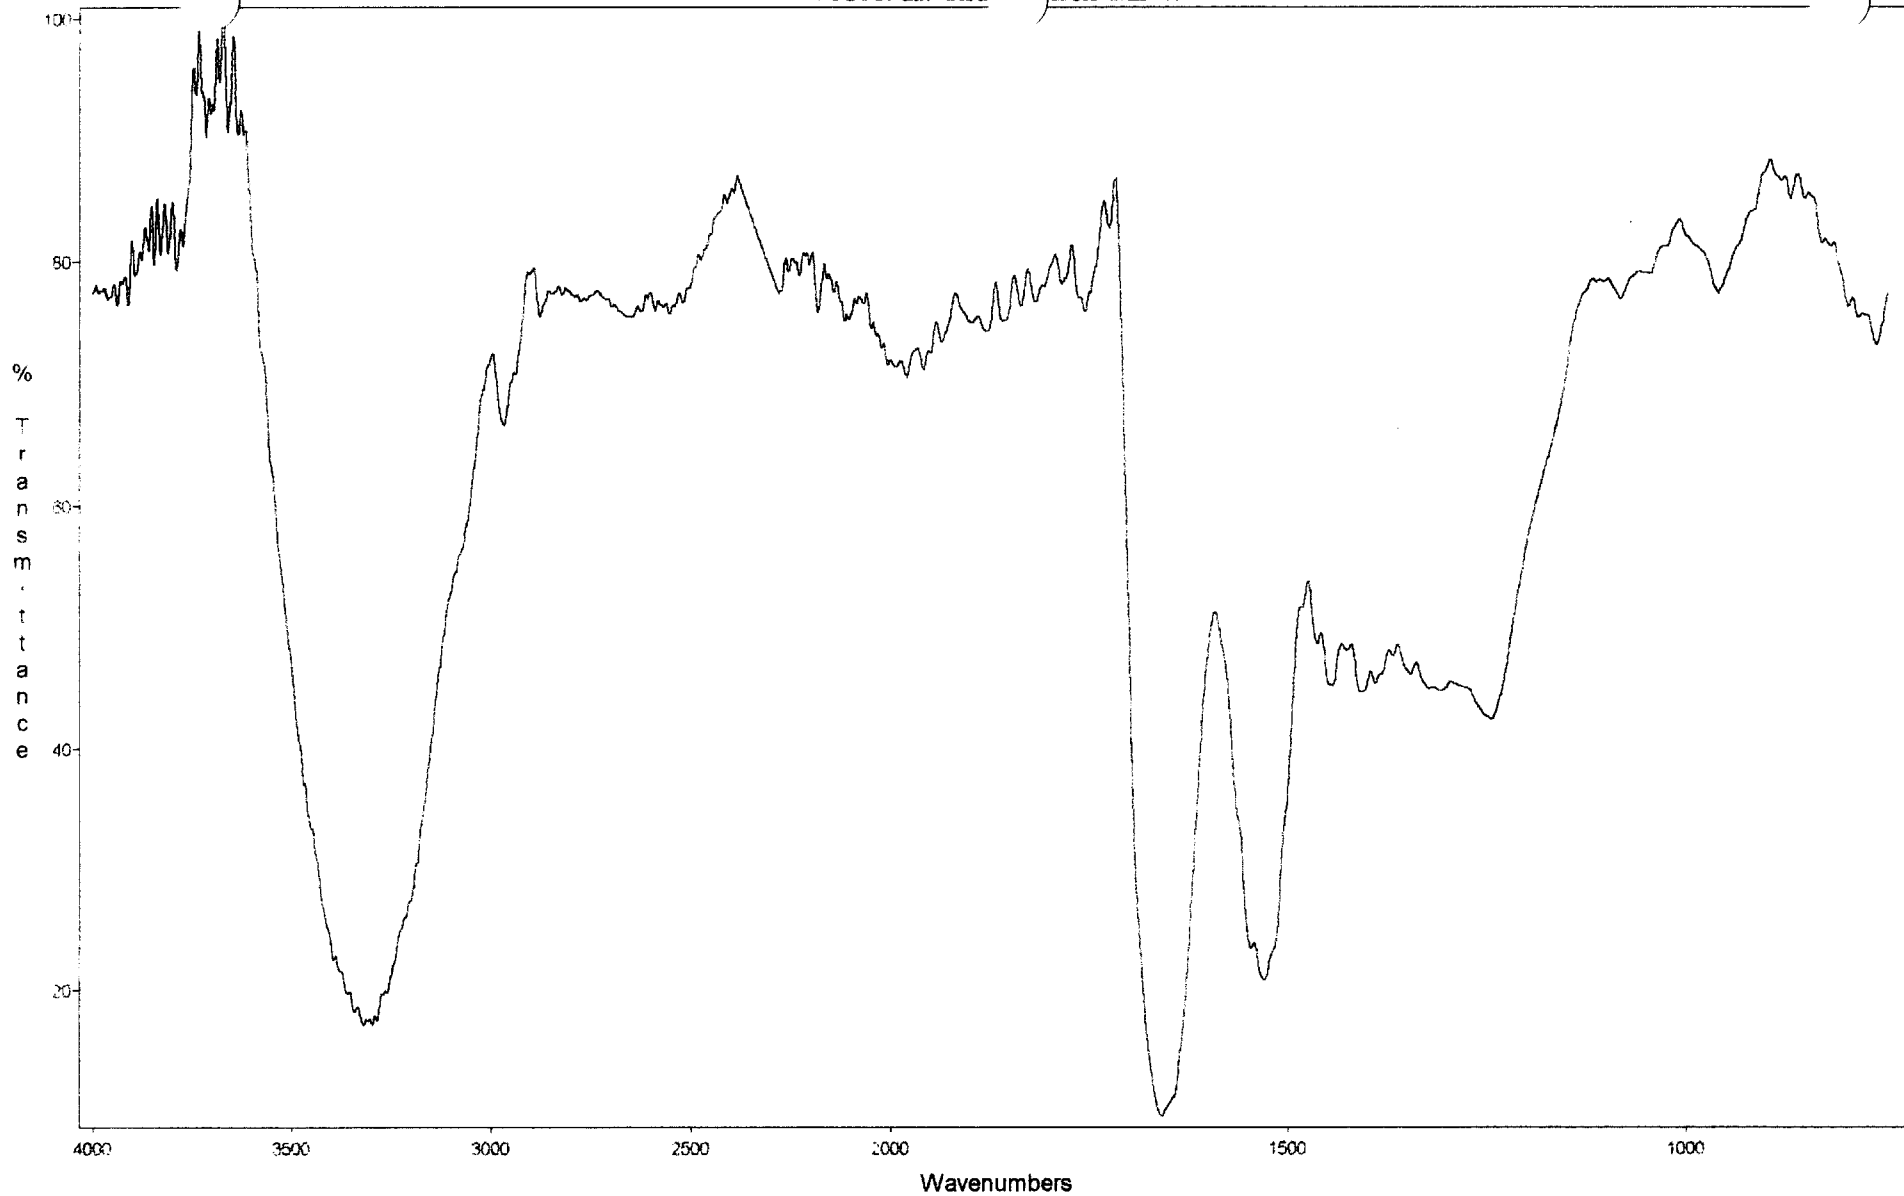
FIGURE 21. RED 'AZLON' FIBER OF SEAT #21-5.

- 3.5 The red fiber as seen in Figure 20 is from the fabric of seat #21-5 and was provided in the sample bag labeled MB-4. The red fiber, the spectrum of which can be seen in Figure 21, is much like Azlon (a manufactured fiber in which the fiber-forming substance is composed of a regenerated naturally occurring protein) and is discussed in 97-1C0063.

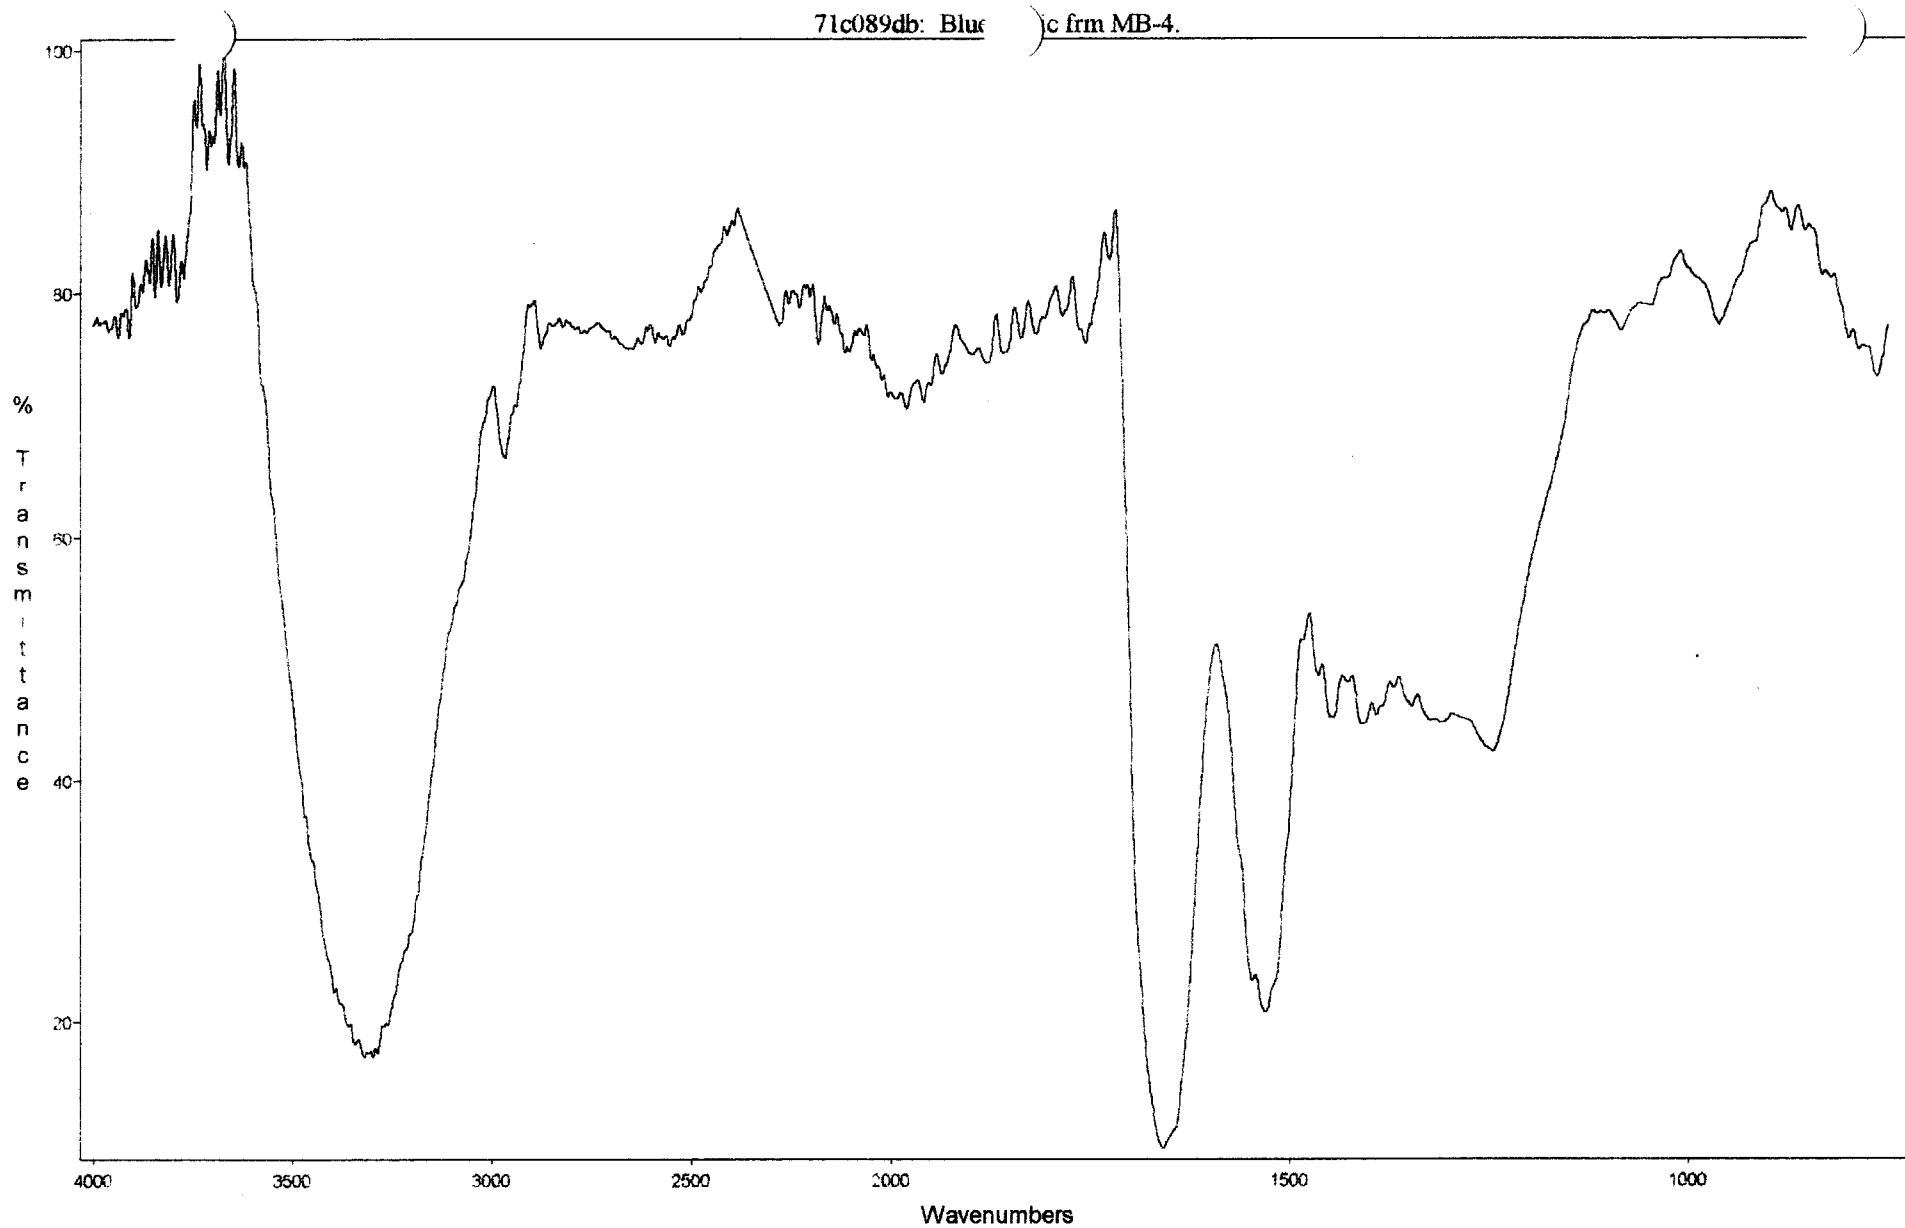
FIGURE 23. BLUE 'AZLON' FABRIC OF SEAT #20-4.

- 3.6 The blue fiber as seen in Figure 22 is from the fabric of seat #20-4 and was provided in the sample bag labeled MB-5. The blue fiber, the spectrum of which can be seen in Figure 23, is similar to Azlon.

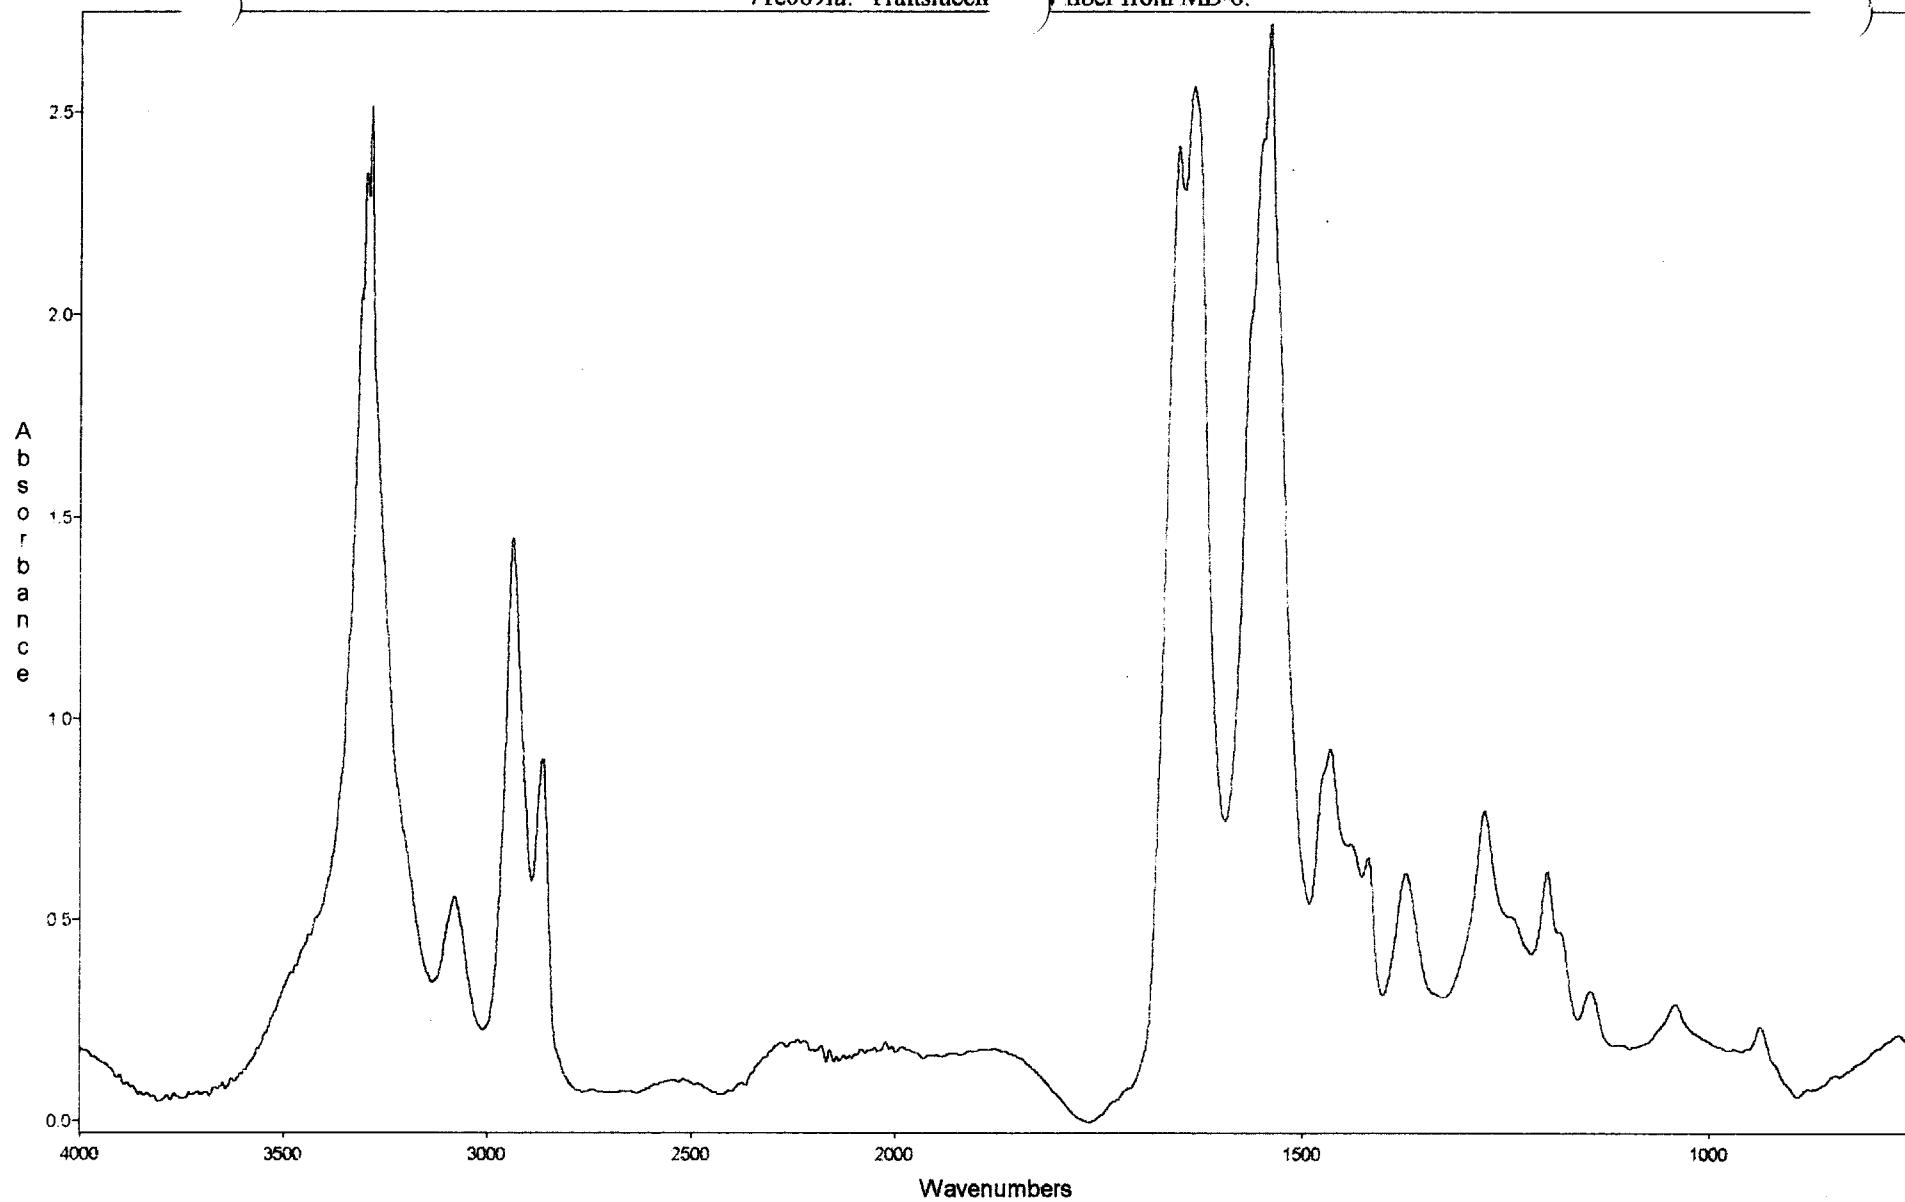
**FIGURE 26. TRANSLUCENT BLUE-GRAY FABRIC FROM
"BLOW-OUT" PANEL COVER #62-75231354.**

- 3.7 Several items were analyzed from the sample bag labeled MB-6, which contained floor carpet from blow out panel cover #62-75231354 (Figure 24). The red fabric is seen in Figure 25 and is the same as presented in 3.5 above. The gray fiber from the carpet material is a polyamide material much like the NylonTM6 series. The IR spectrum is provided in Figure 26.

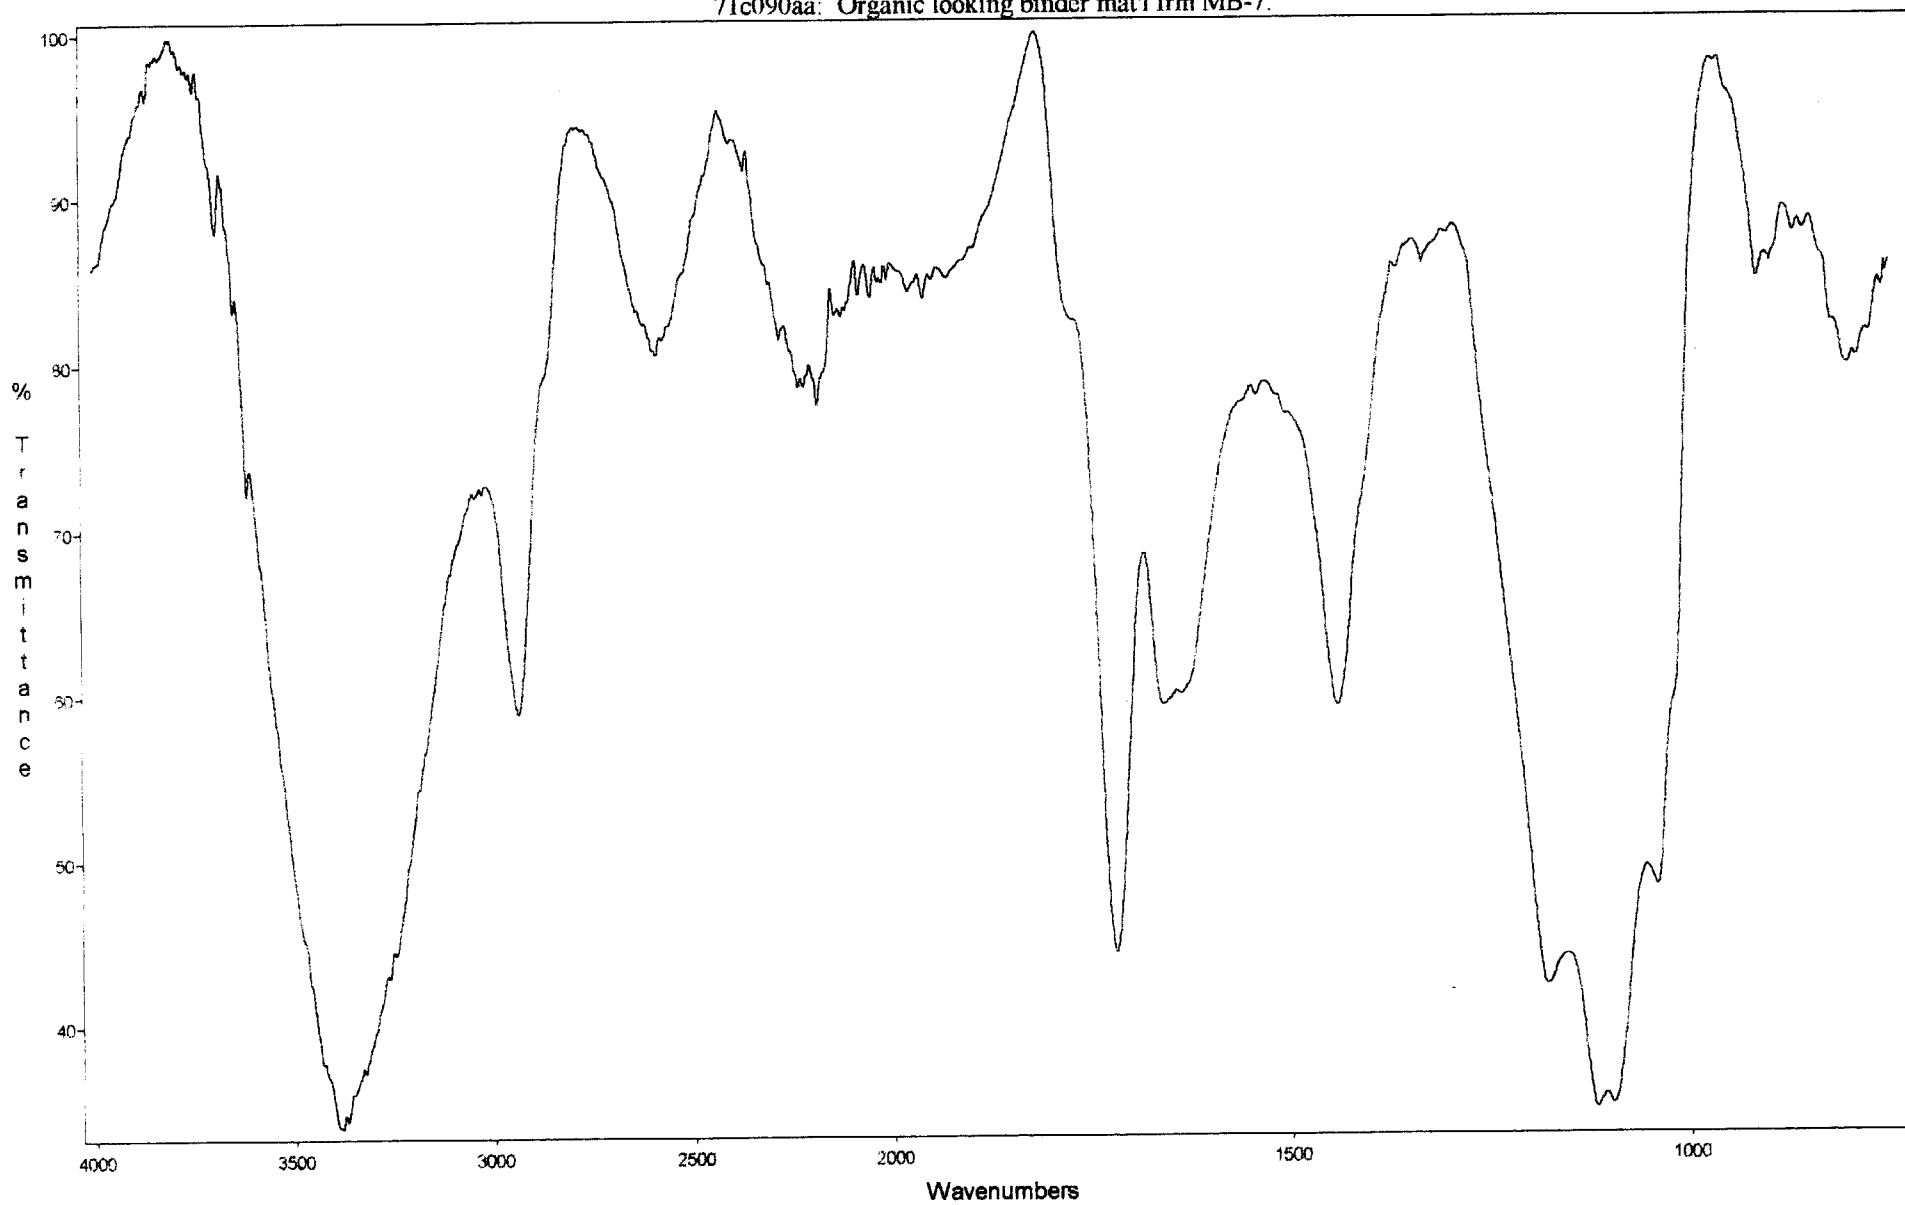
FIGURE 2. IR SPECTRUM OF BINDER MATERIAL.

- 4.1 The red, tinted binder material seen in Figure 1, was identified by FTIR as a [monomeric ester] substance commonly used as ceramic additives, strengtheners, plasticizers and binders. The IR spectrum of the material is shown in Figure 2.

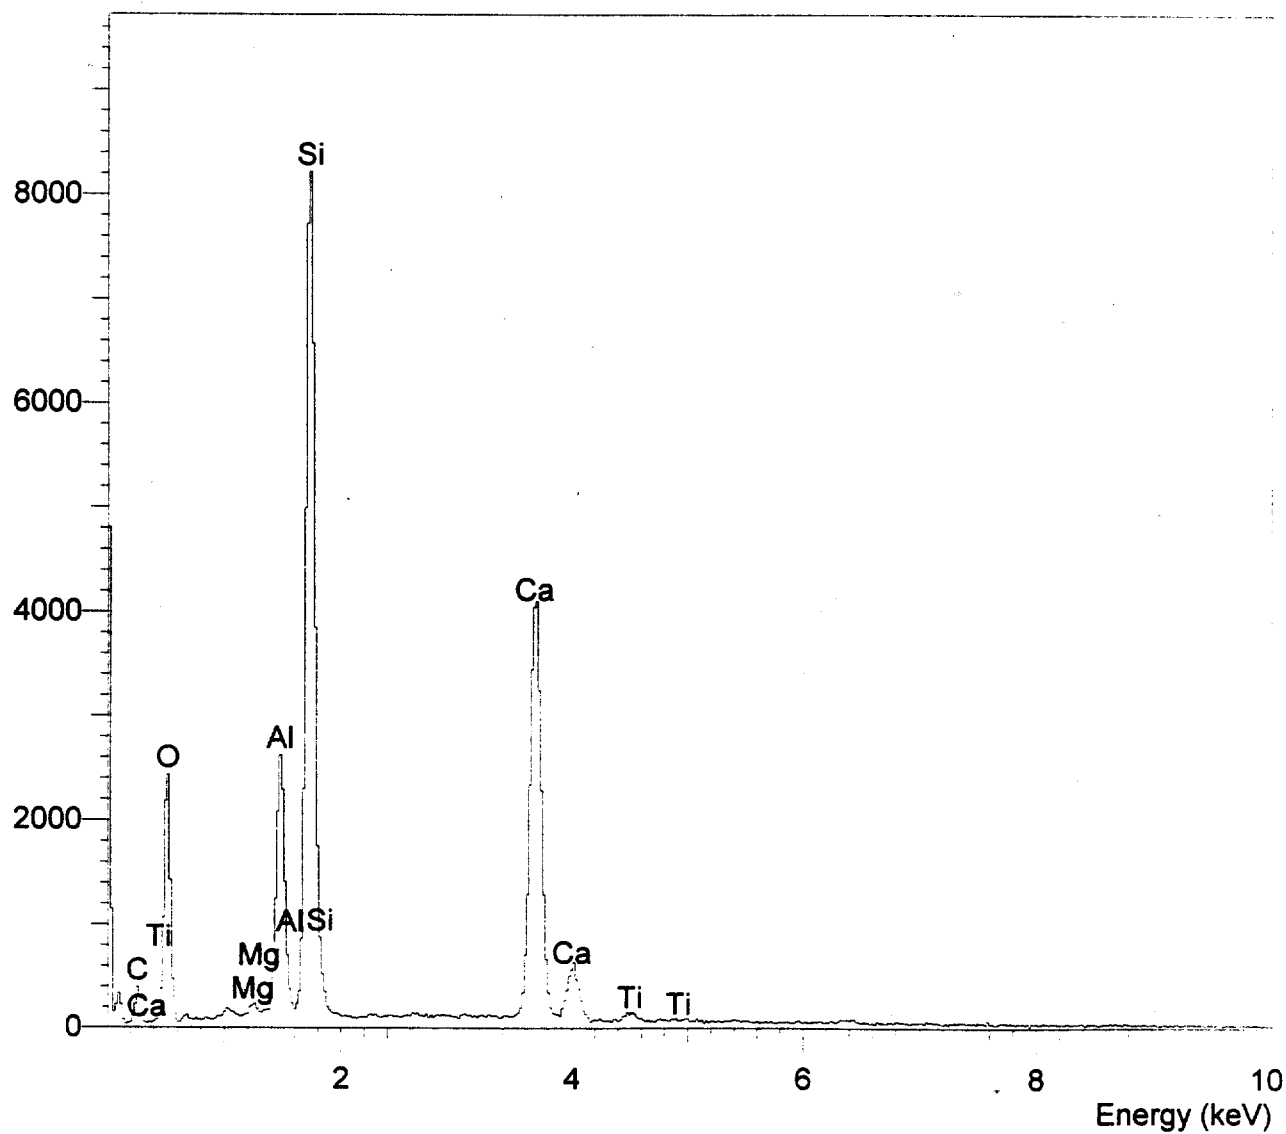
FIGURE 3. EDS OF FIBER.

- 4.2 EDS analysis of an isolated fiber, indicates high concentrations of silicon, moderate amounts of calcium, aluminum and oxygen, with trace amounts of carbon, magnesium and titanium also present. The EDS chart is provided as Figure 3.

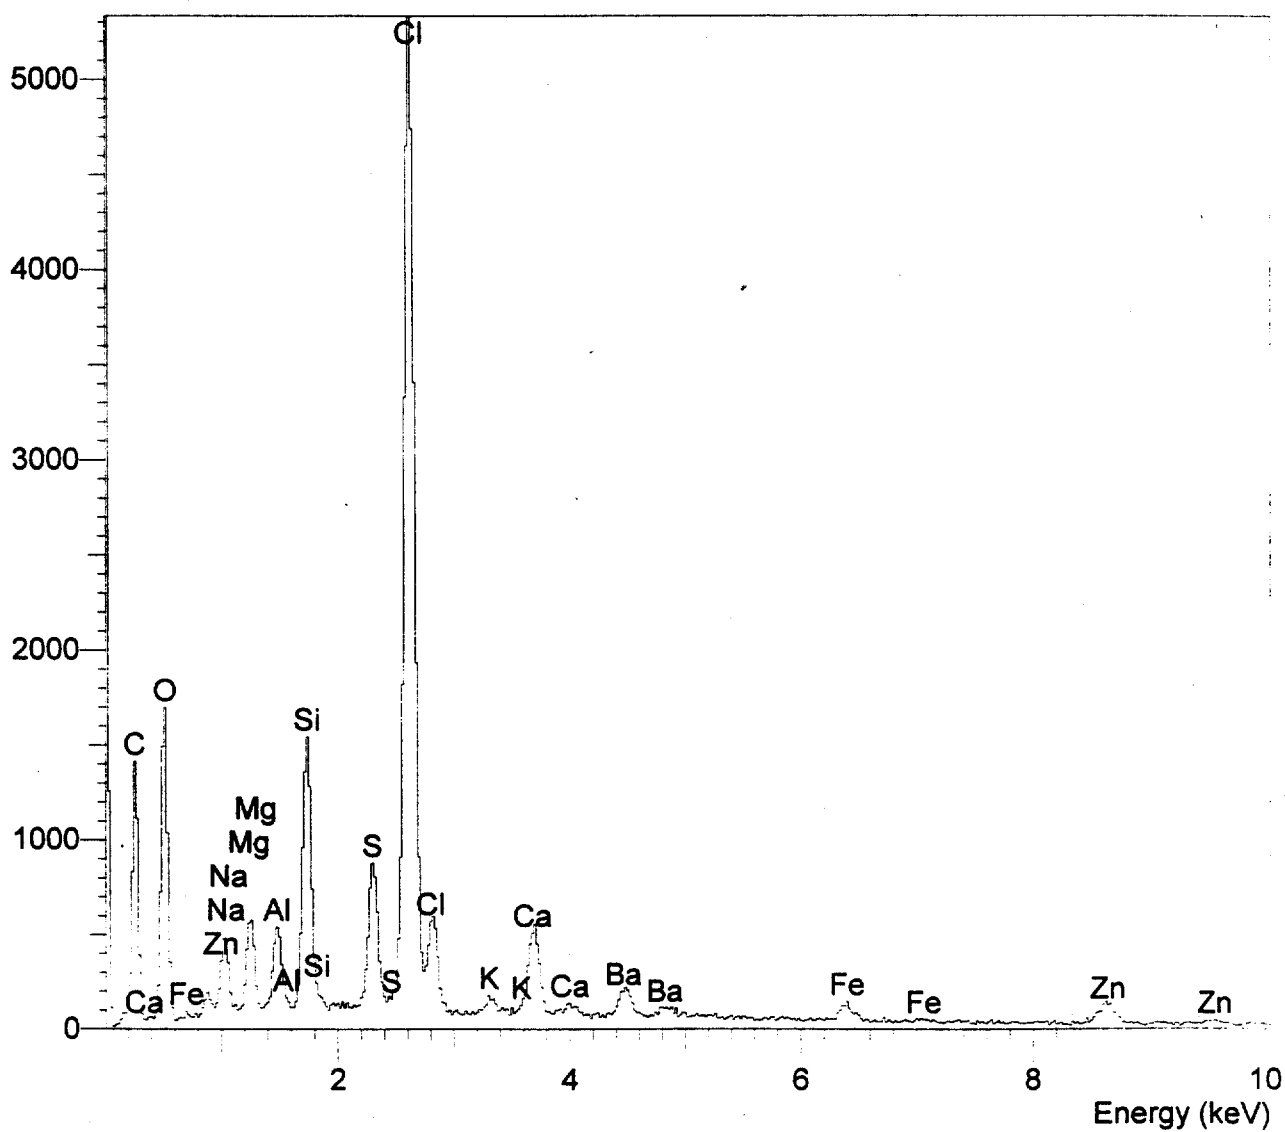
FIGURE 4. EDS OVERVIEW OF "OUTER" SIDE.

- 4.3 An EDS analysis of the surface of the outer side (Refer to Figure 1) shows high concentrations of chlorine, moderate amounts of oxygen, silicon and carbon with minor amounts of sulfur, sodium, magnesium, aluminum, potassium, calcium, barium, iron and zinc. The EDS chart of these results is provided in Figure 4.

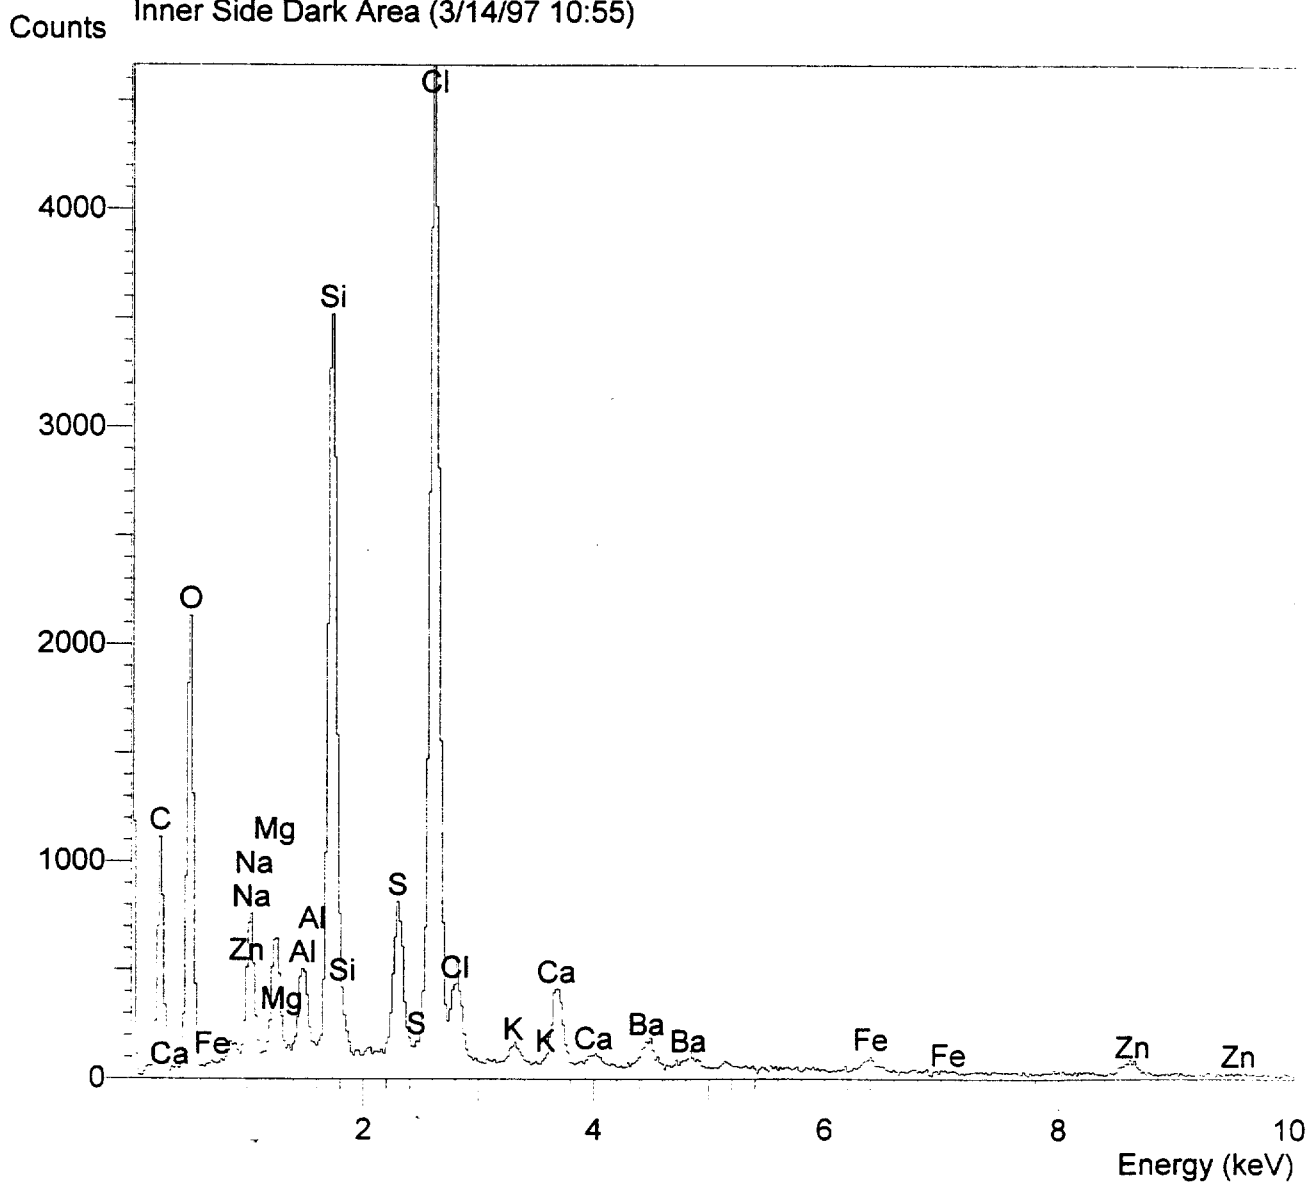
FIGURE 6. EDS OF DARK AREA OF "INNER" SIDE.

- 4.4 An EDS analysis of the dark tinted surface area on the inner side of the sample (Refer to Figure 5) shows high concentrations of chlorine, moderate amounts of oxygen, silicon, carbon and sodium with minor to trace amounts of sulfur, magnesium, aluminum, potassium, calcium, barium, iron and zinc. The EDS chart of these findings is provided in Figure 6.

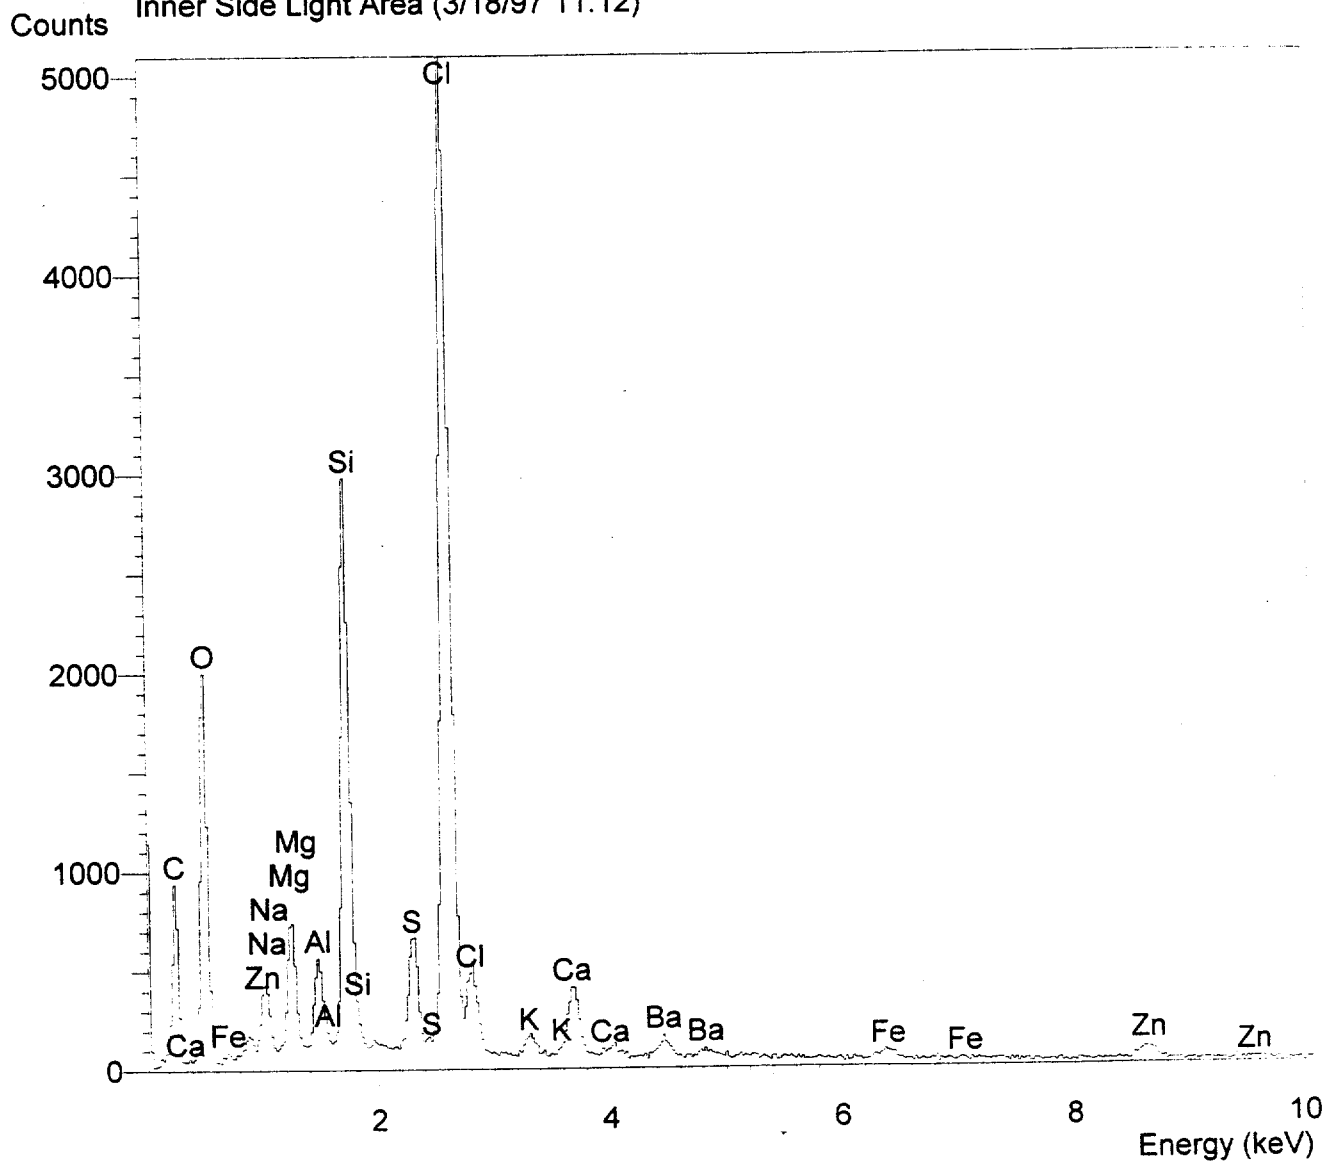
FIGURE 7. EDS OF LIGHT AREA OF "INNER" SIDE.

- 4.5 An EDS analysis of the light tinted surface area on the inner side of the sample (Refer to Figure 5) shows high concentrations of chlorine, moderate amounts of oxygen, silicon, carbon and sodium with minor to trace amounts of sulfur, magnesium, aluminum, potassium, calcium, barium, iron and zinc. The EDS chart reflecting these measurements is provided in Figure 7.

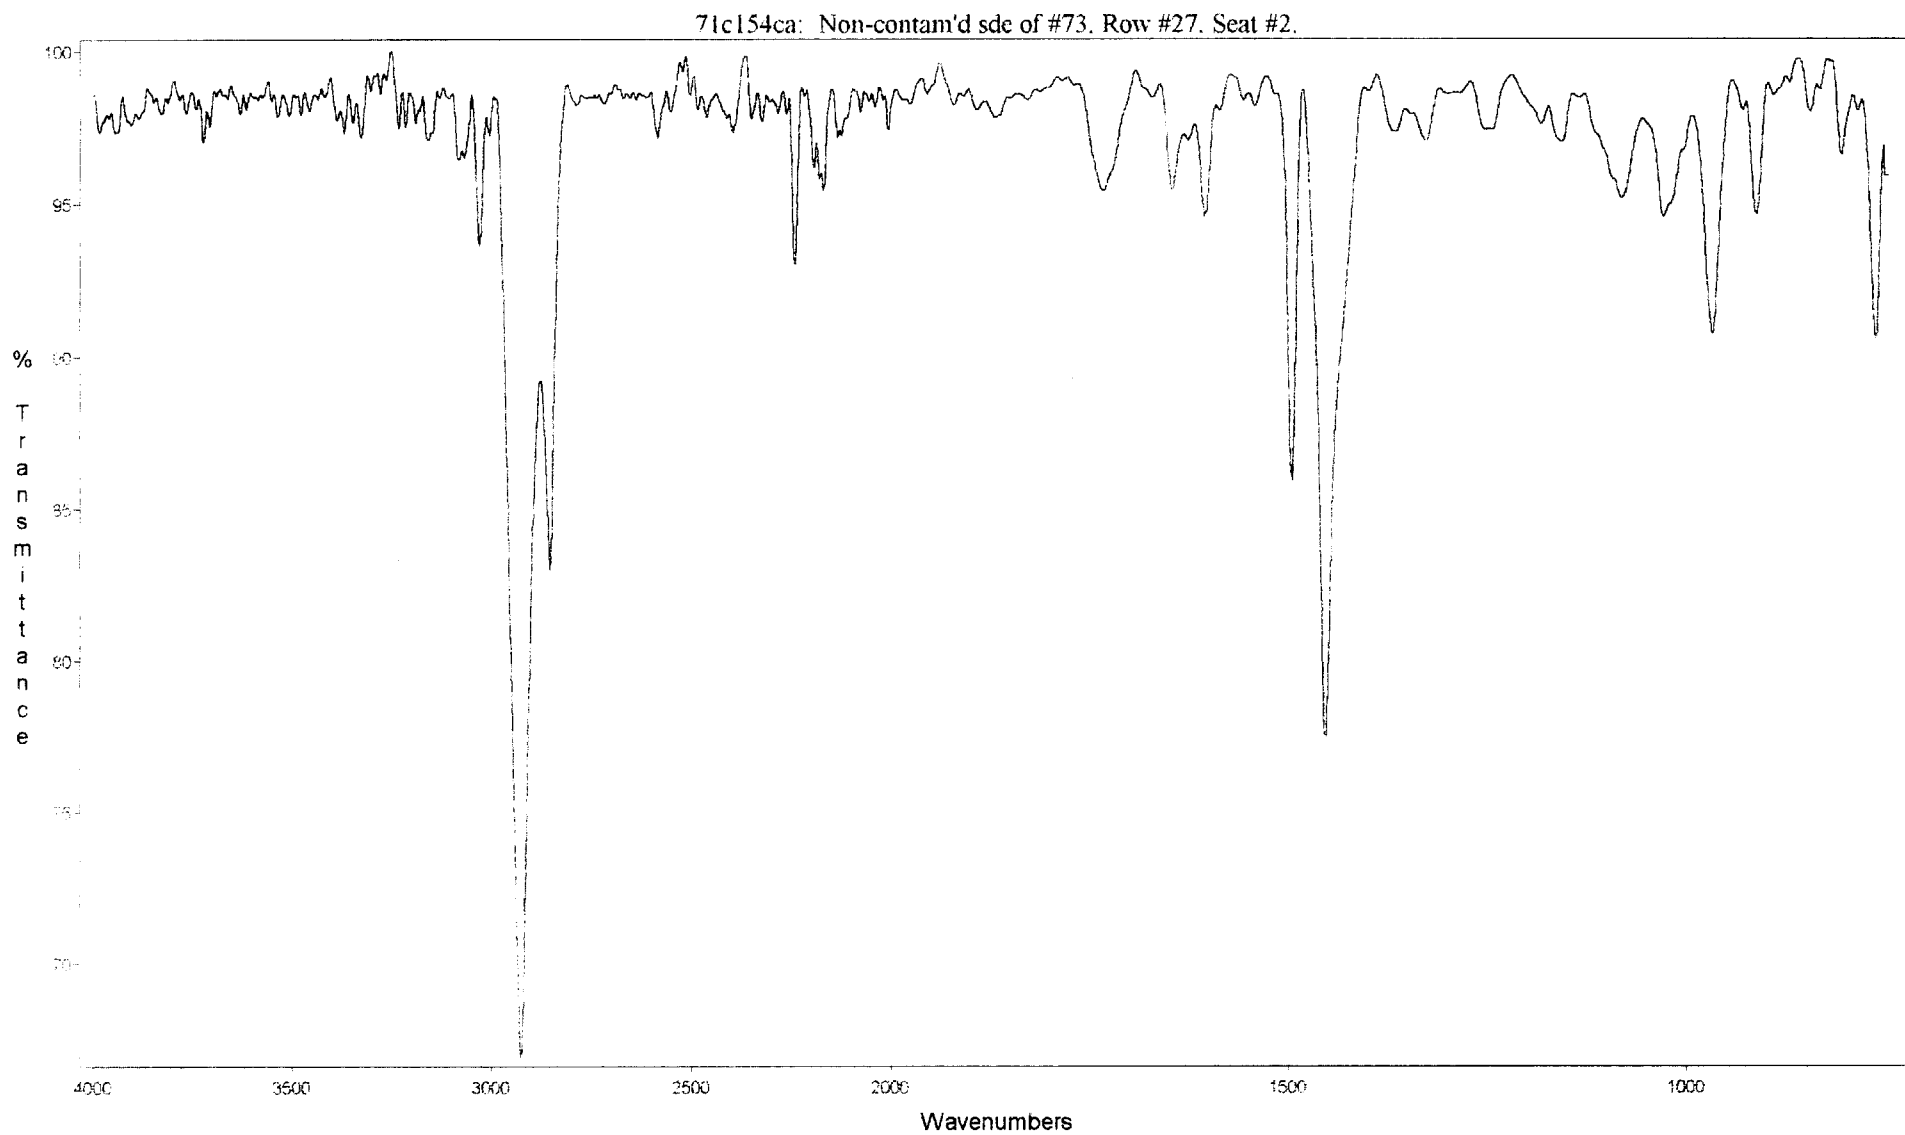
Figure 13. IR spectrum of "clean" side of sample #73, Row #27, Seat #2.

- 3.4 The plastic or vinyl material from sample #73, Row 27, Seat 2 (Figure 12) was contorted much like the deformation which occurs when exposed to heat, whereas the material of sample #70 was smooth and exhibited no such altered conformation. Additionally, the unknown material which was attached to one side of sample #73 was tan or reddish-brown, whereas the contaminated side of sample #70 was red. The spectrum for the clean side of sample #73 is provided in Figure 13 and the spectrum for the contaminated side of the sample is provided in Figure 14. A spectral comparison of the reference adhesive and the red-brown material is provided in Figure 15 and a spectral overlay in Figure 16.

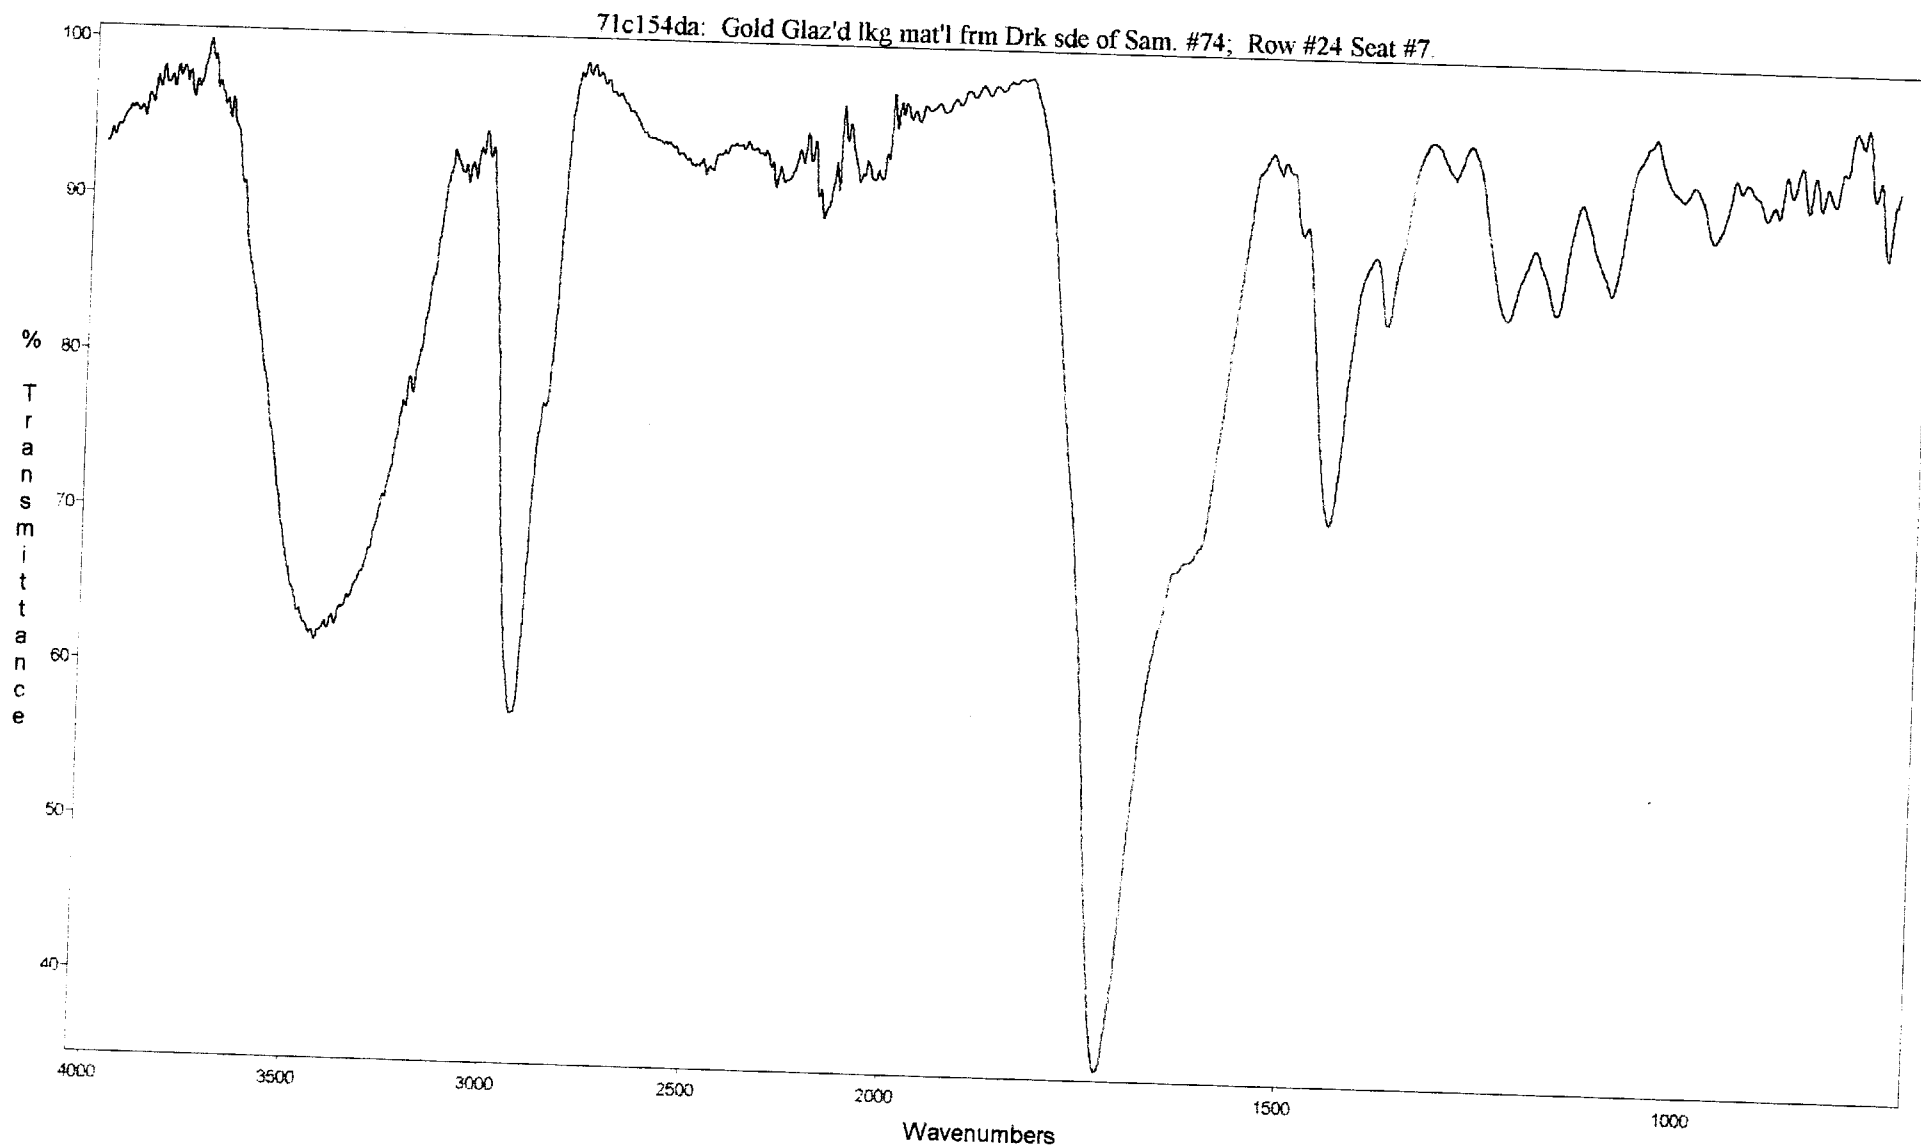
Figure 18. Glazed looking material from darkest side of sample #74.

- 3.5 Sample #74, Row 24, Seat 7 (Figure 17) appeared to be a metal alloy (probably aluminum) and was characterized by charred material on both sides. Material from each side was removed and FTIR spectra generated. For the purposes of this discussion, the terms "darker side" and "lighter side" will be used to differentiate between the two sides. A gold colored glazed and a black organic appearing material were removed from the darker side and spectra generated. The FTIR spectra for each is provided in Figure 18 and Figure 19 respectively. From the lighter side, a "soot" looking material was extracted with an organic solvent and a spectrum generated. The spectrum is provided in Figure 20.

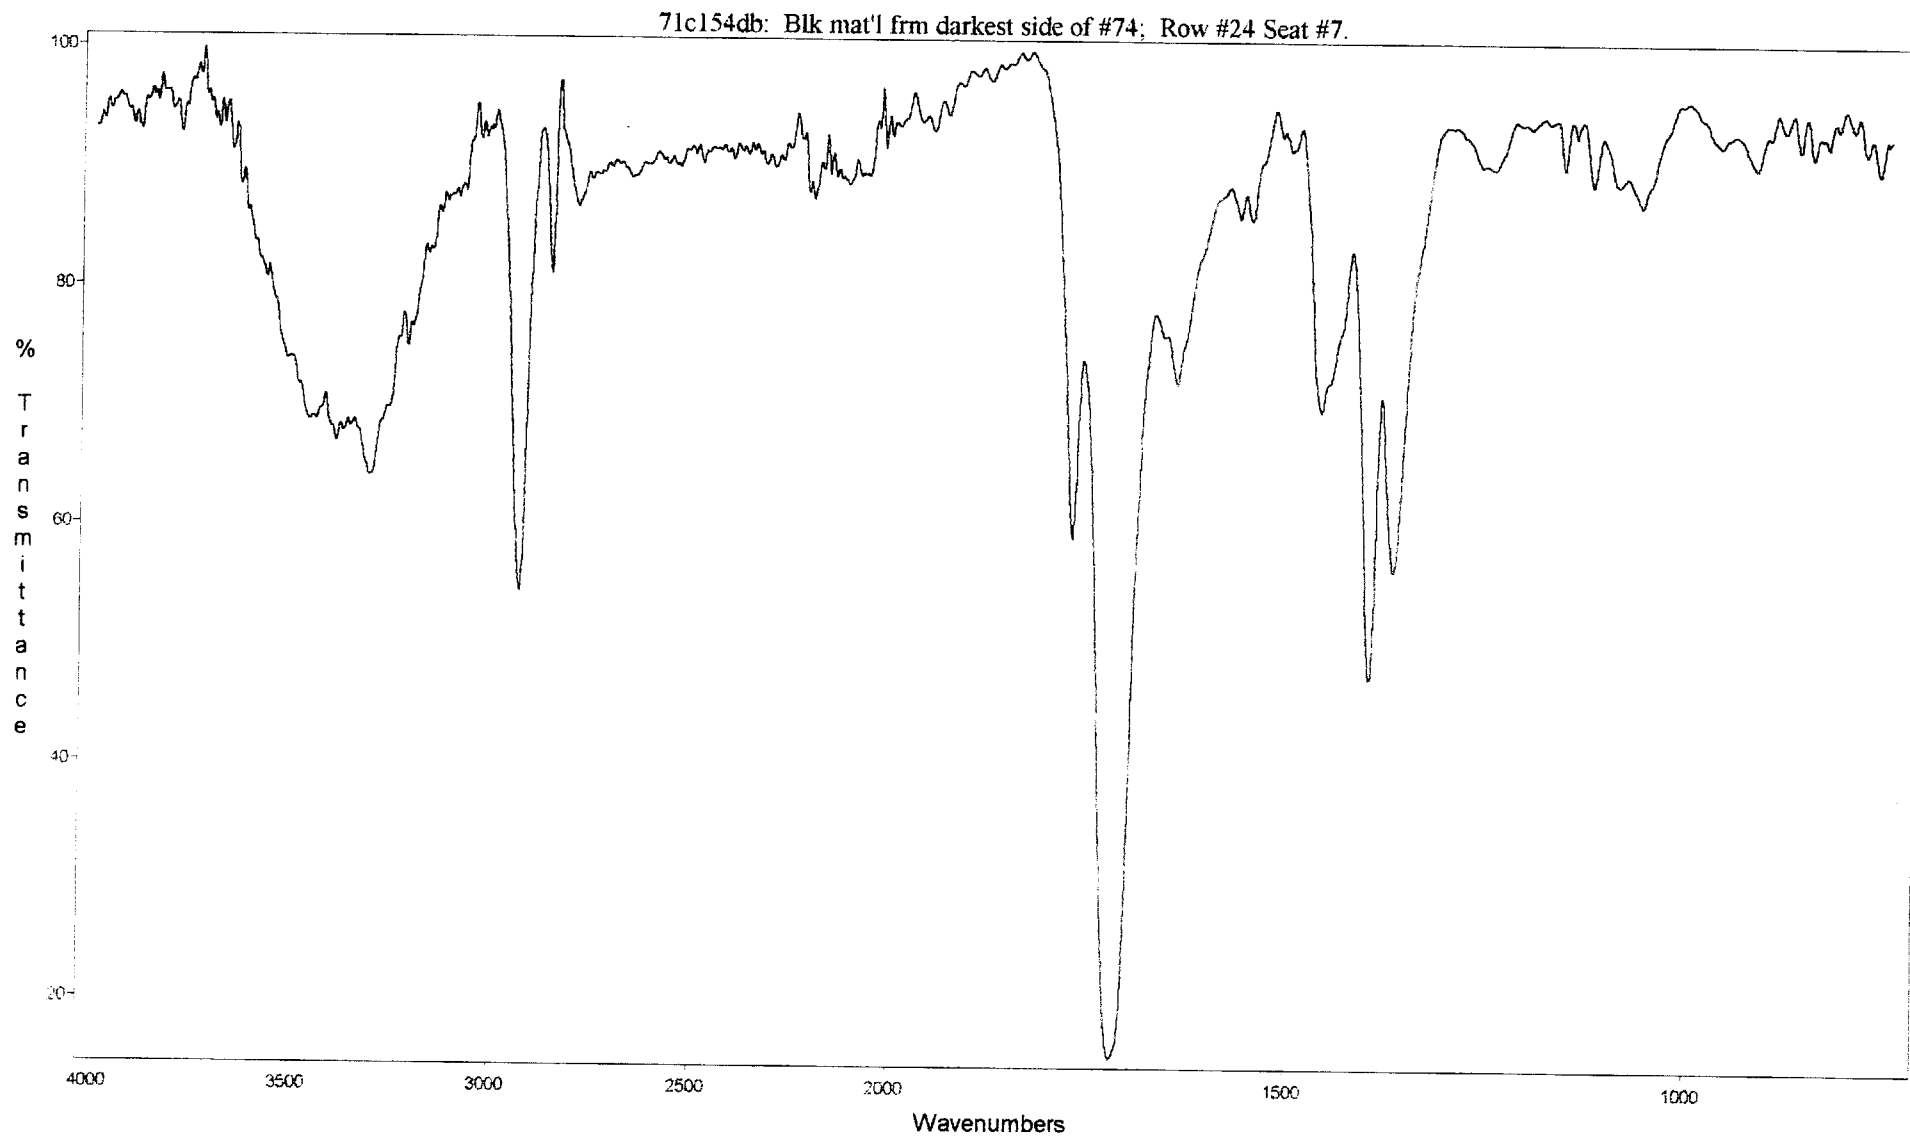
- 4.5 The gold glazed looking material removed from the darker side of sample #74, was identified as an acrylic polymer. The black looking material from the darker side of the metal was identified as a phthalate resin product, probably a DacronTM filler. The presence of an anti-static agent was also detected. The same organic presence was observed on the lighter side of the metal sample although it was much less abundant. Since it is plausible to expect similar results from these materials, they were not examined further. There was a "soot" like substance present on this side that was not found on the previous side. This soot material was extracted, concentrated to dryness and analyzed. The IR data indicates that the major component of the "sooty" material is a zinc oxide which could be the oxidized phase of a zinc based polyvinyl chloride stabilizer.

Figure 19. Black material from darkest side of sample #74.
